Marine Corrosion Studies

The Effects of Dissimilar Metal Couples and Toxicants from Antifouling Paints on the Corrosion of 5086 and 6061 Aluminum Alloys and Their Response to Cathodic Protection

(Fourteenth Interim Report of Progress)

T. J. LENNOX, JR., M. H. PETERSON, J. A. SMITH,
AND R. E. GROOVER

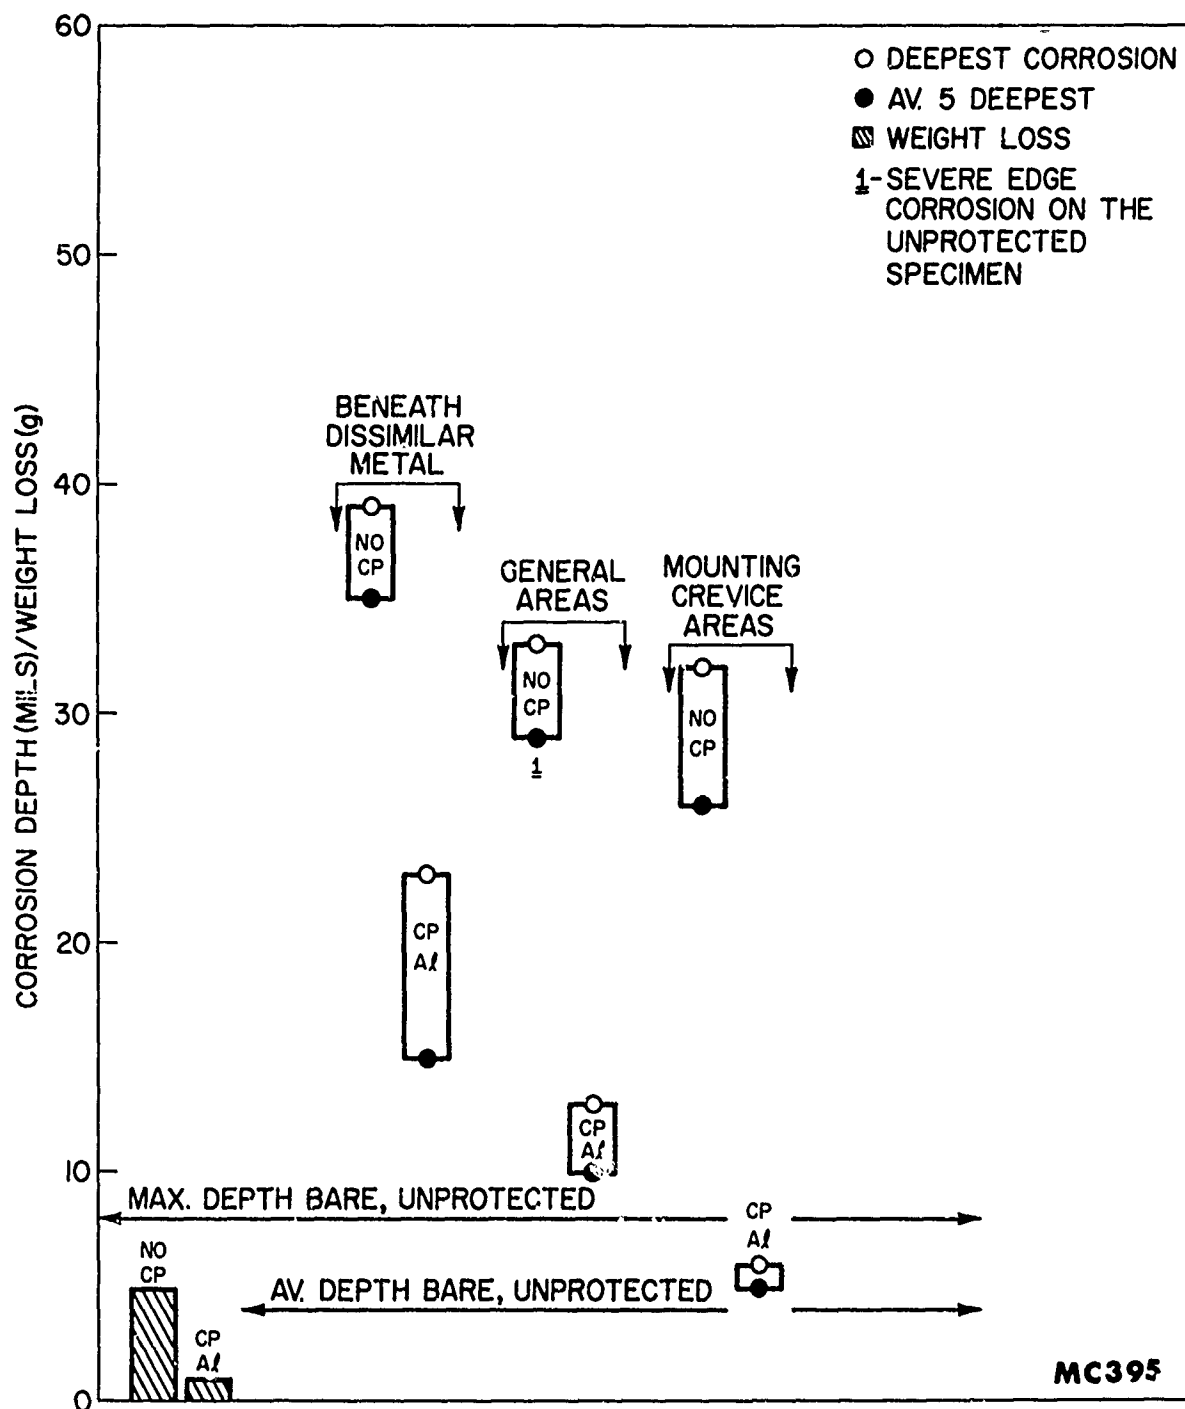
Fig. 6 - 5086-H32 aluminum coupled to yellow brass; with and without cathodic protection (CP), 809 days in seawater at Key West, Florida.

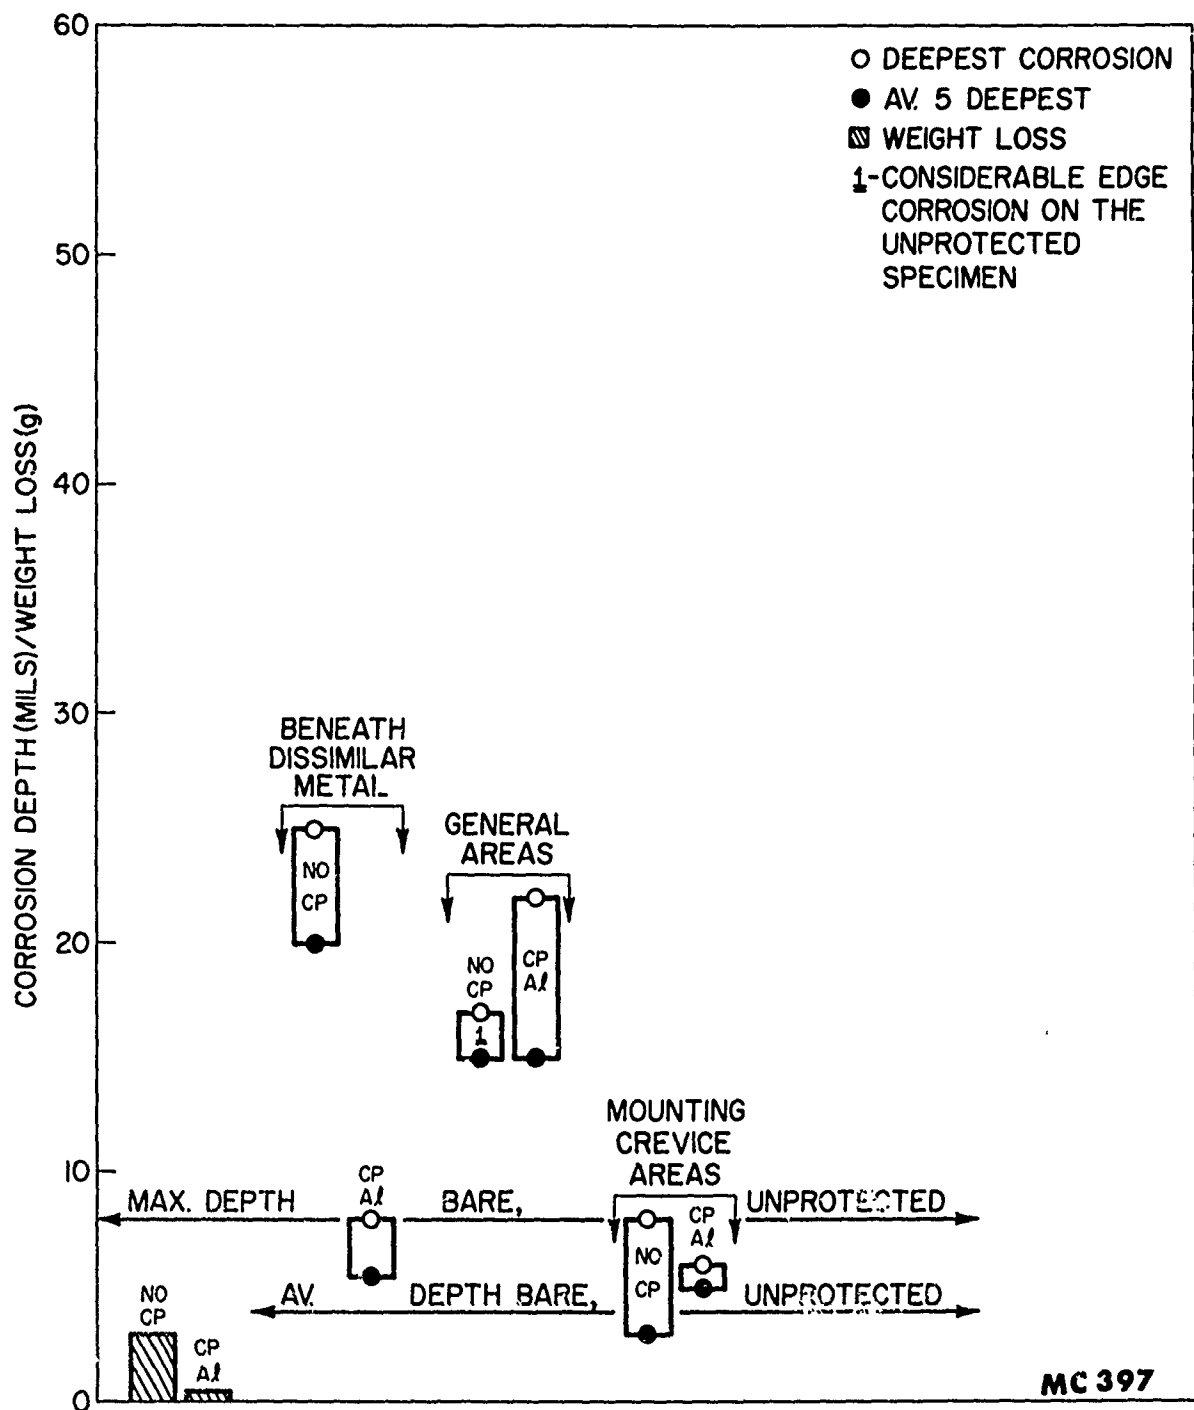
Fig. 8 - 5086-H32 aluminum coupled to mild steel; with and without cathodic protection (CP), 809 days in seawater at Key West, Florida.

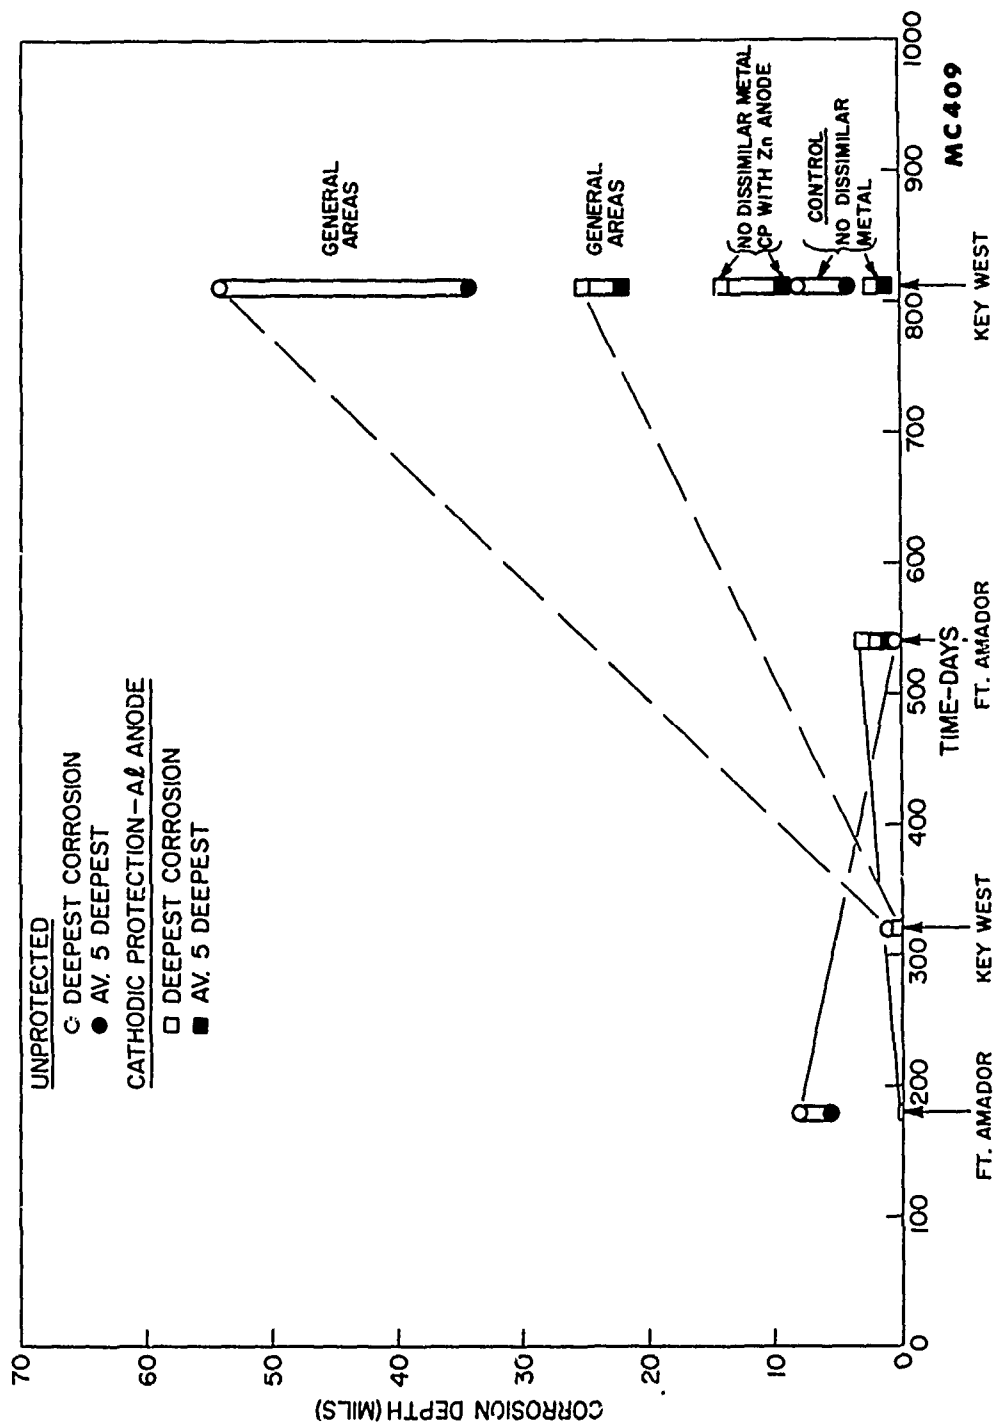
Fig. 20 - 5086-H32 aluminum coupled to copper nickel, 10%; with and without cathodic protection (CP). Data from various exposure times in seawater at Key West, Florida and Ft. Amador, Canal Zone.

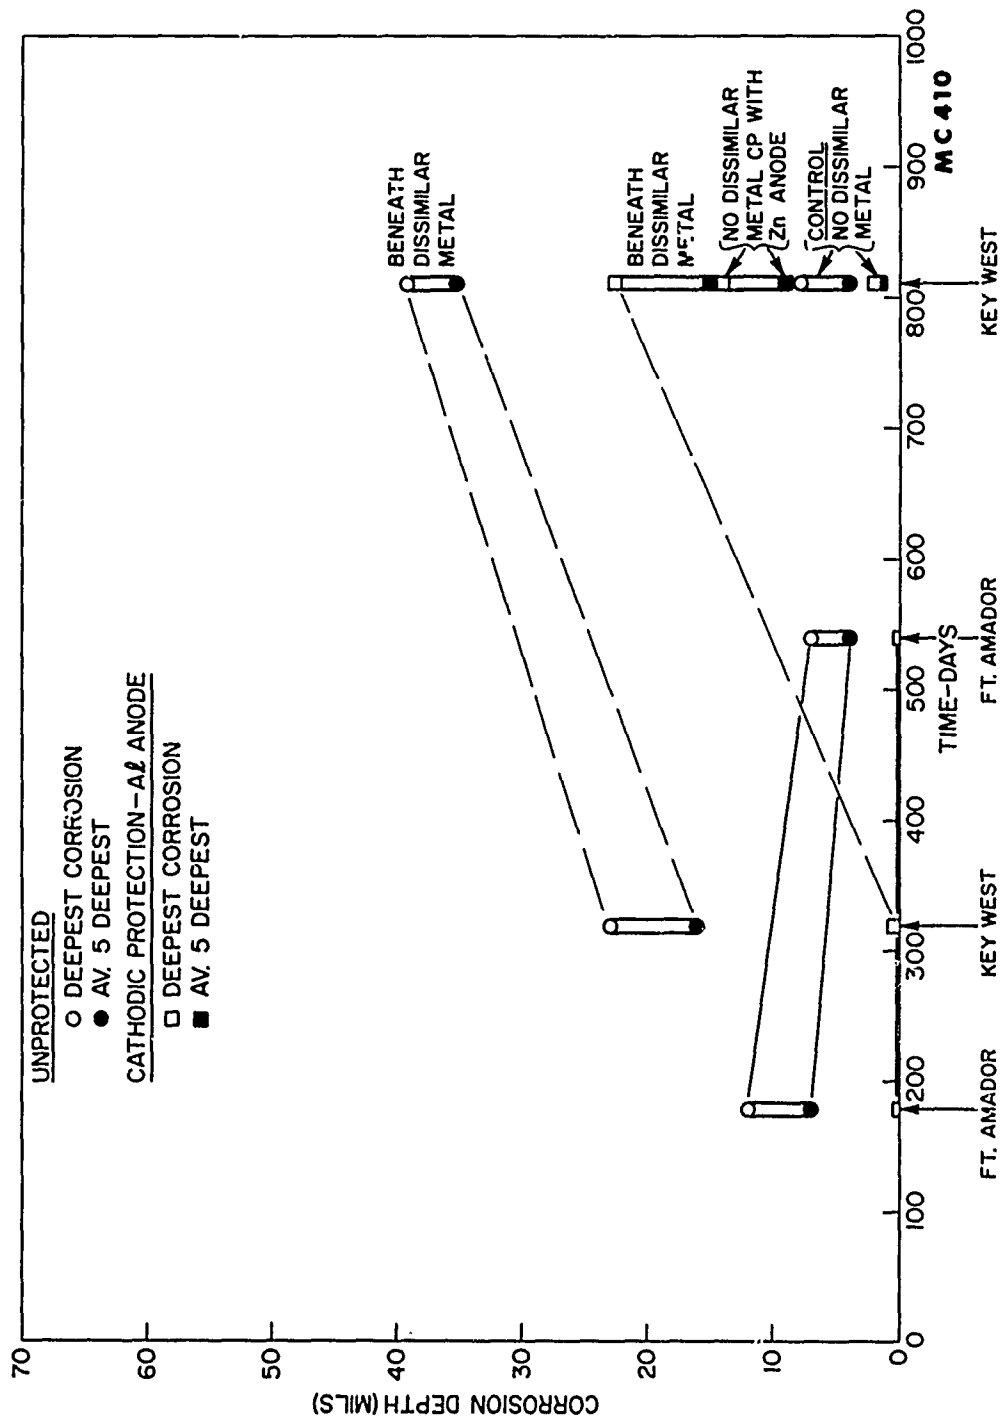
Fig. 21 - 5086-H32 aluminum coupled to yellow brass; with and without cathodic protection (CP). Data from various exposure times in seawater at Key West, Florida and Ft Amador, Canal Zone.

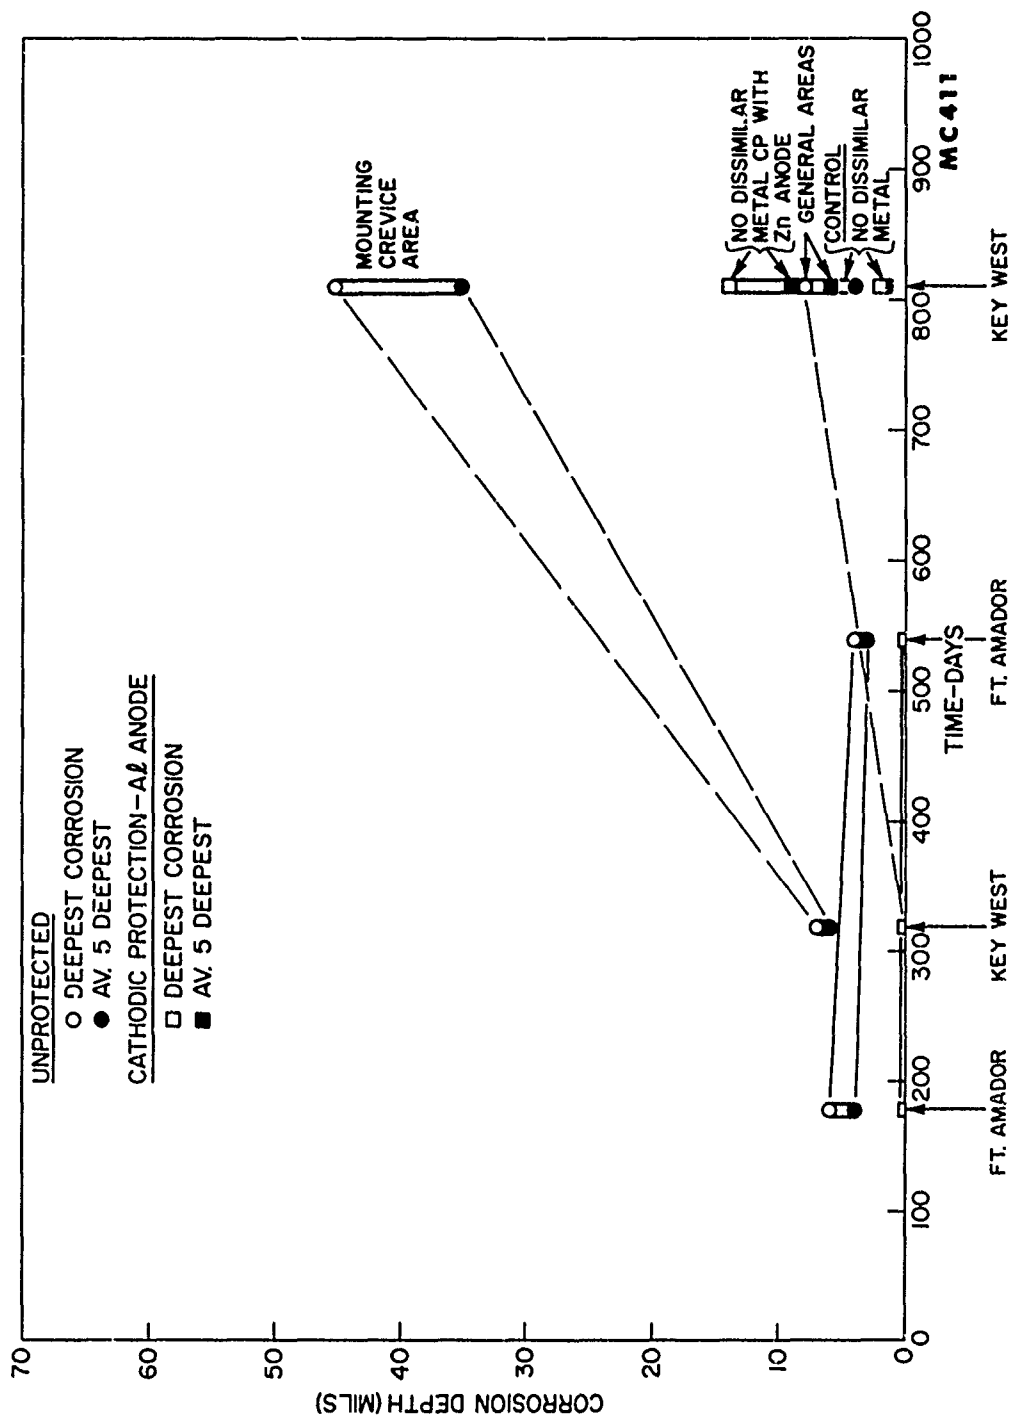
Fig. 22 - 5086-H32 aluminum coupled to 304 stainless steel; with and without cathodic protection (CP). Data from various exposure times in seawater at Key West, Florida and Ft. Amador, Canal Zone.

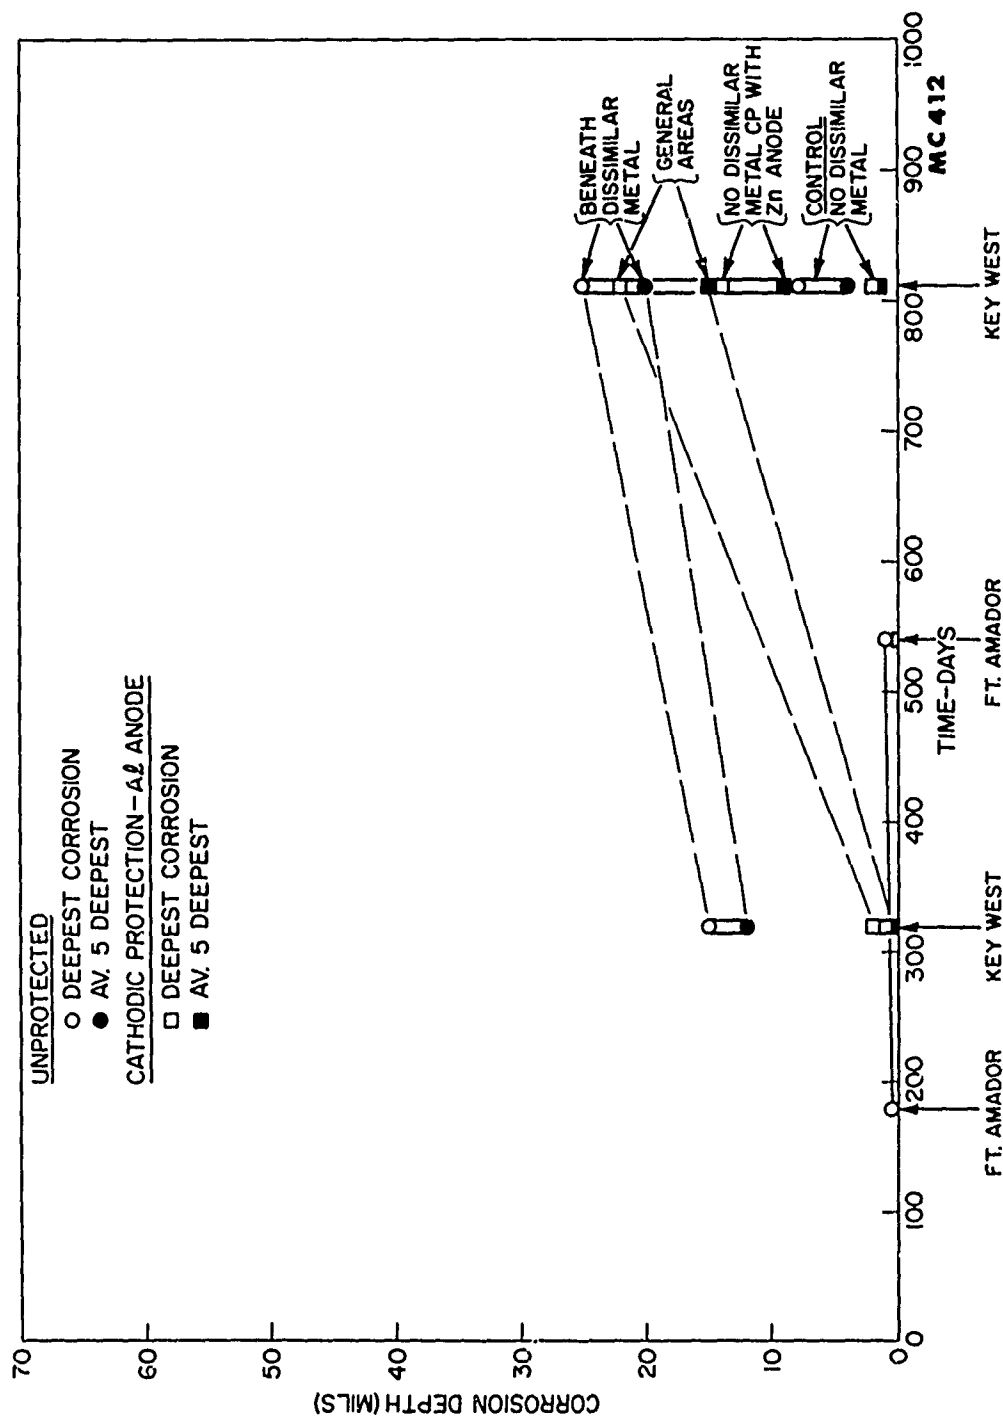
Fig. 23 - 5086-H32 aluminum coupled to mild steel; with and without cathodic protection (CP). Data from various exposure times in sea-water at Key West, Florida and Ft. Amador, Canal Zone.

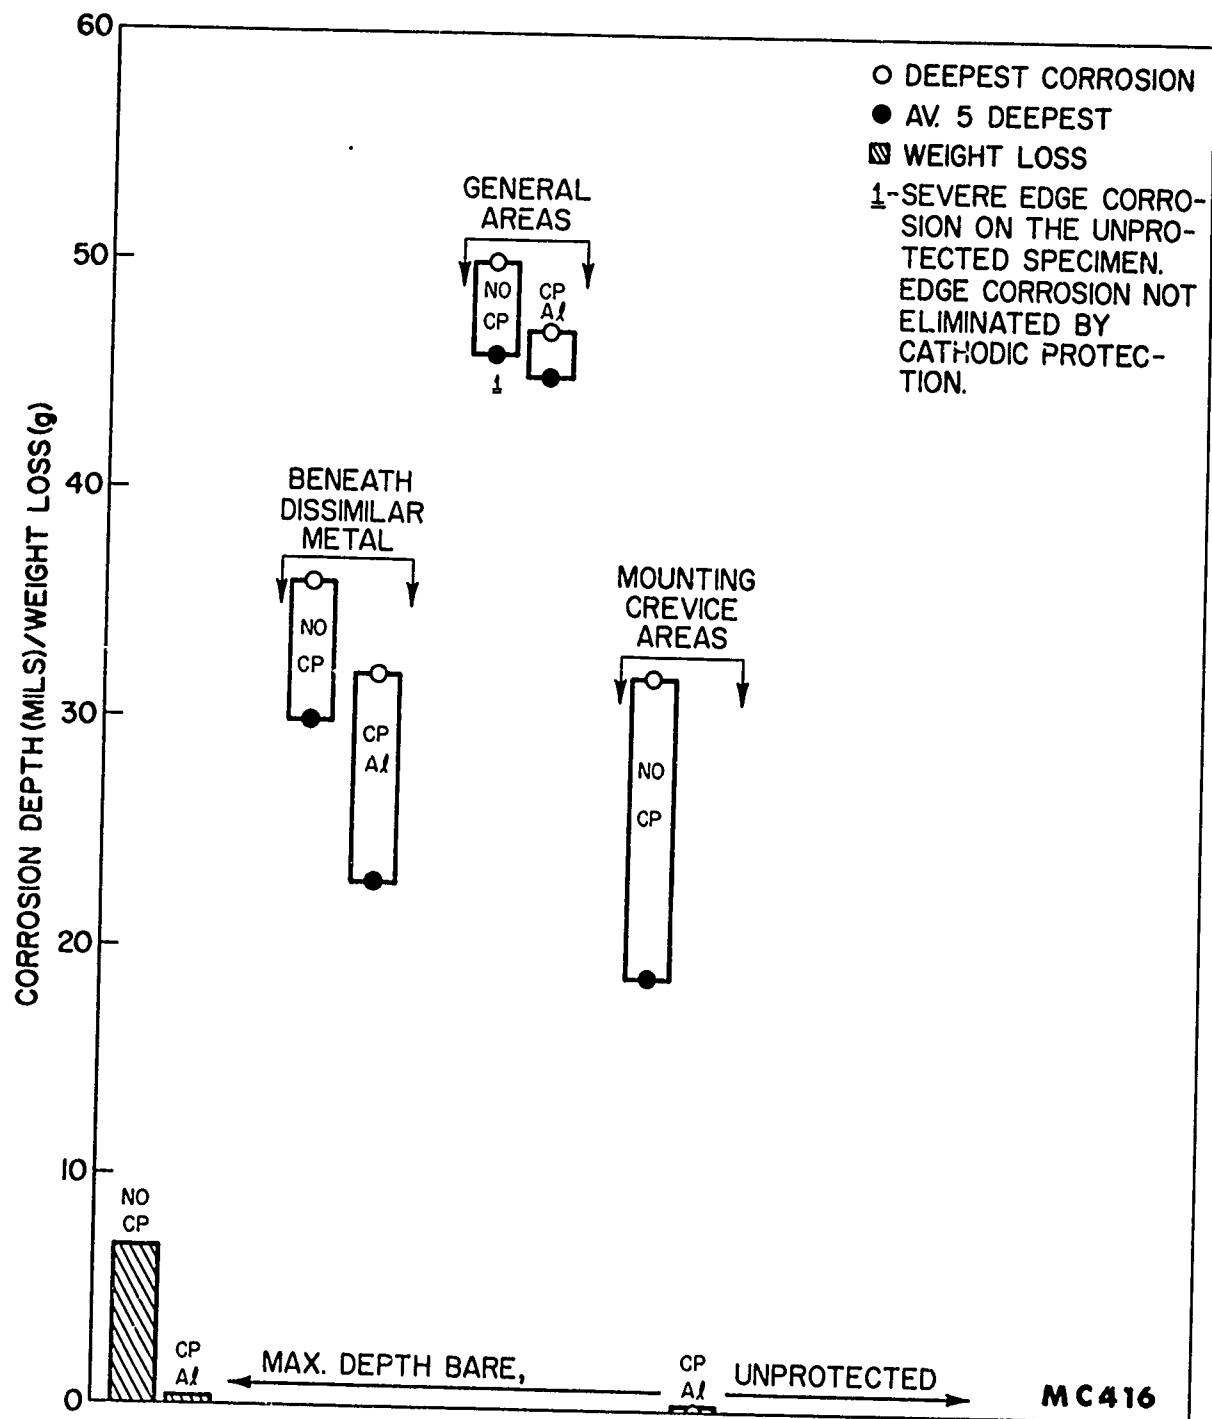
Fig. 27 - 5086-H23 aluminum coupled to yellow brass; with and without cathodic protection (CP), 675 days in the Potomac River.

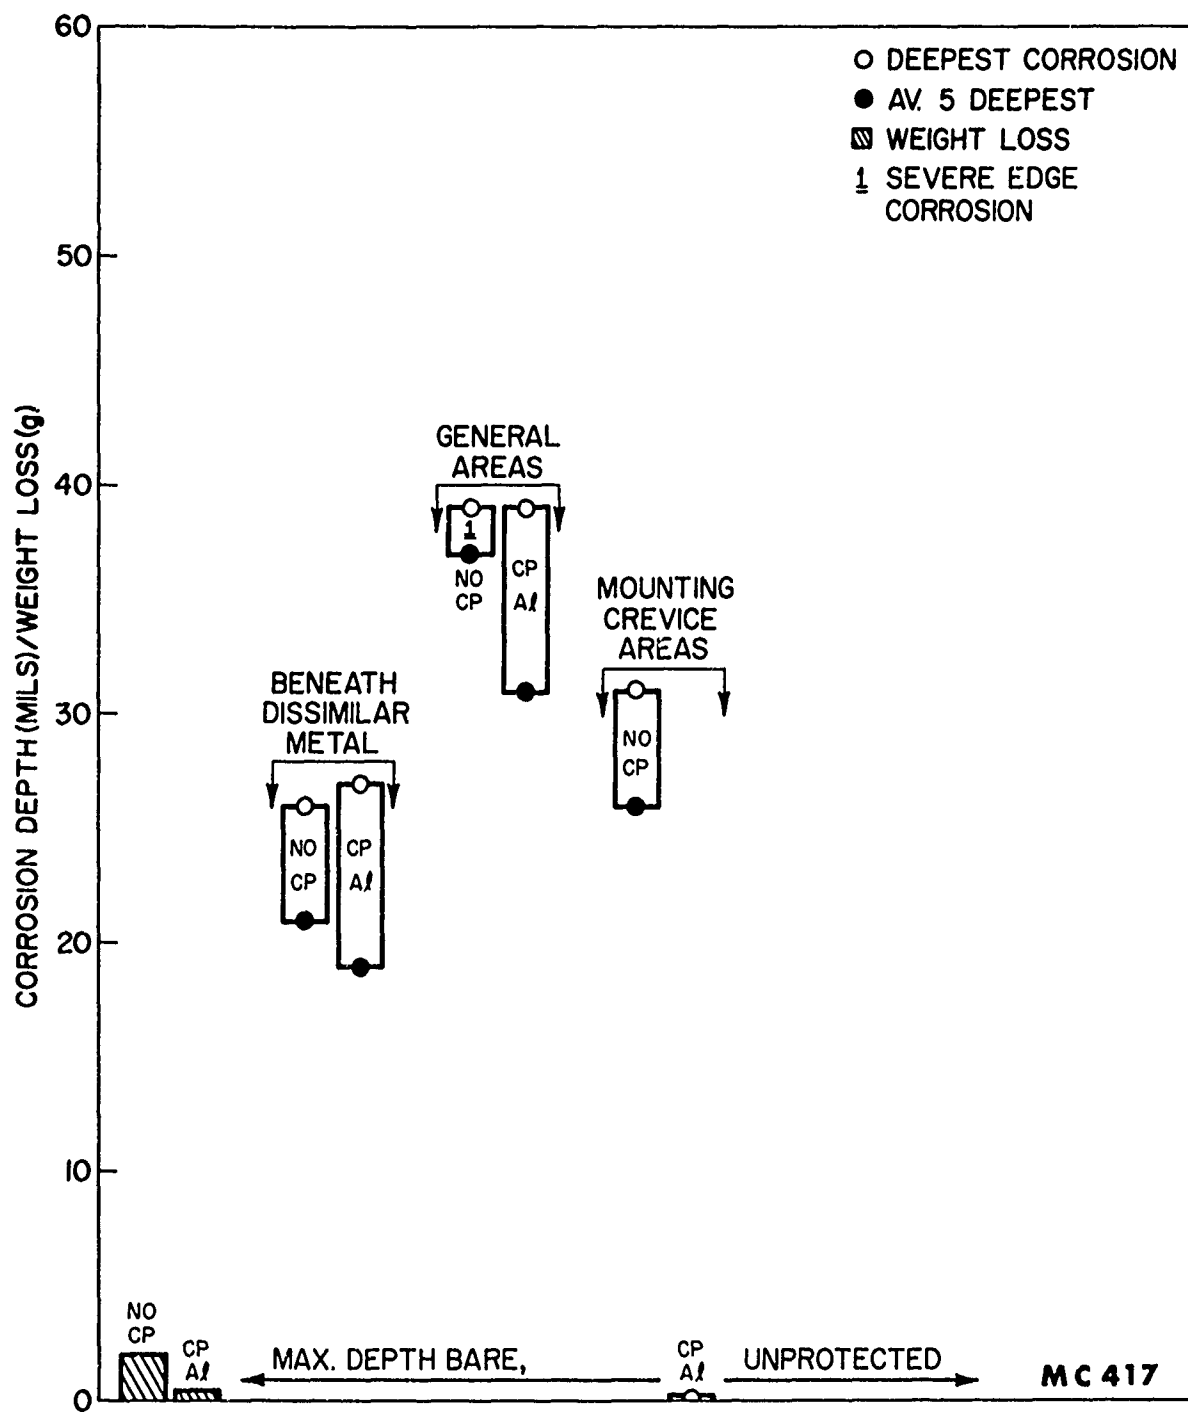
Fig. 28 - 5086-H32 aluminum coupled to 304 stainless steel; with and without cathodic protection (CP), 675 days in the Potomac River.

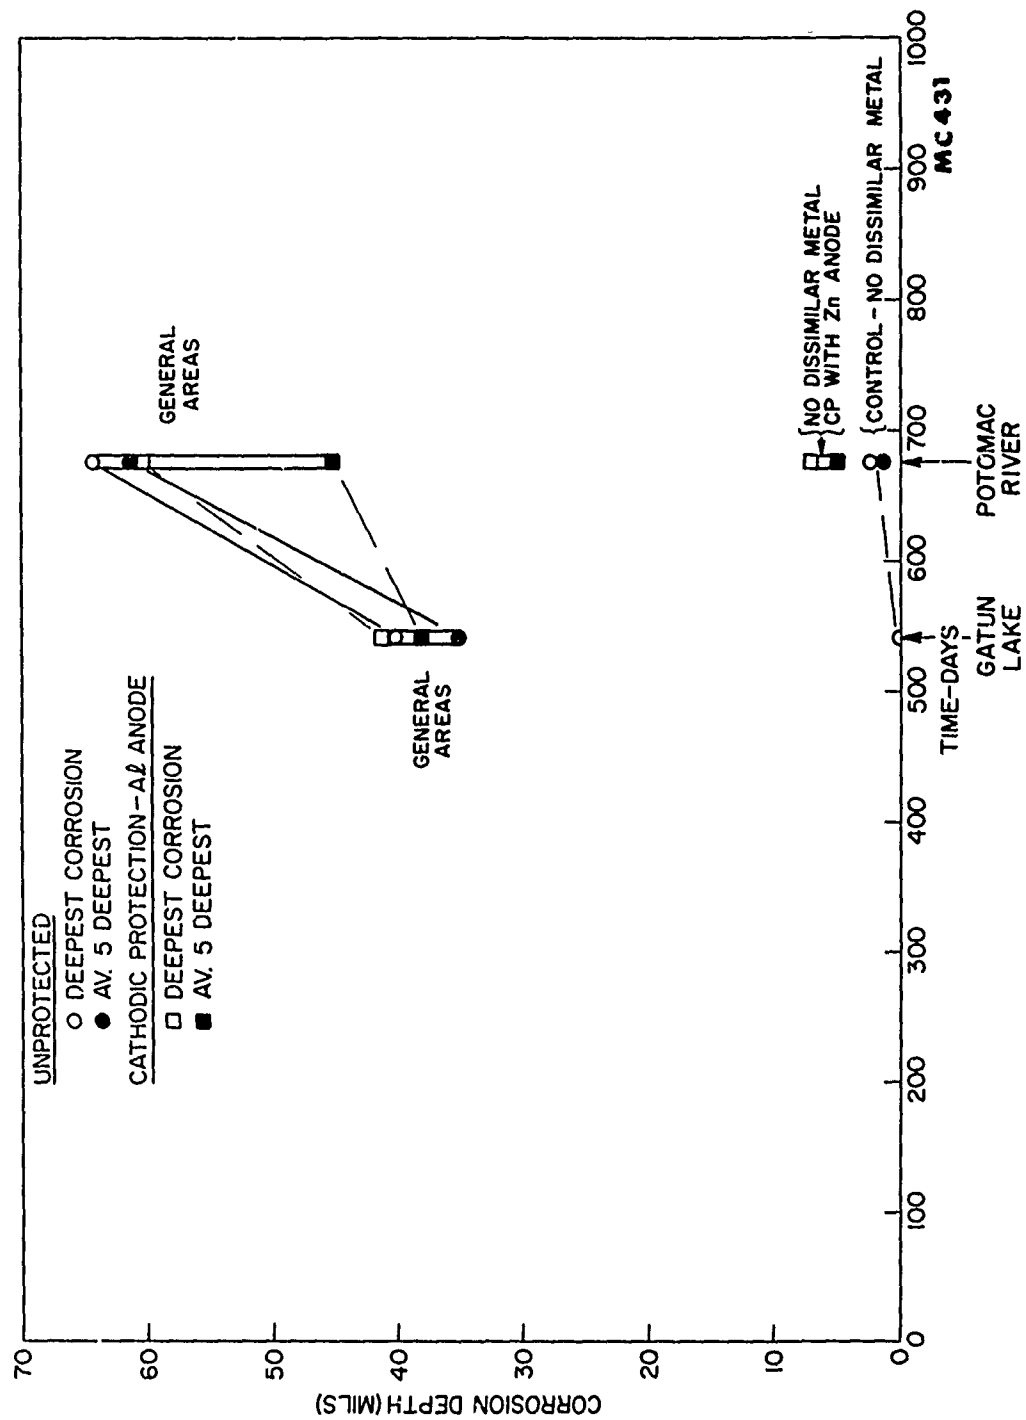
Fig. 42 - 5086-H32 aluminum coupled to copper nickel, 10%; with and without cathodic protection (CP). Data from Gatun Lake and the Potomac River exposures.

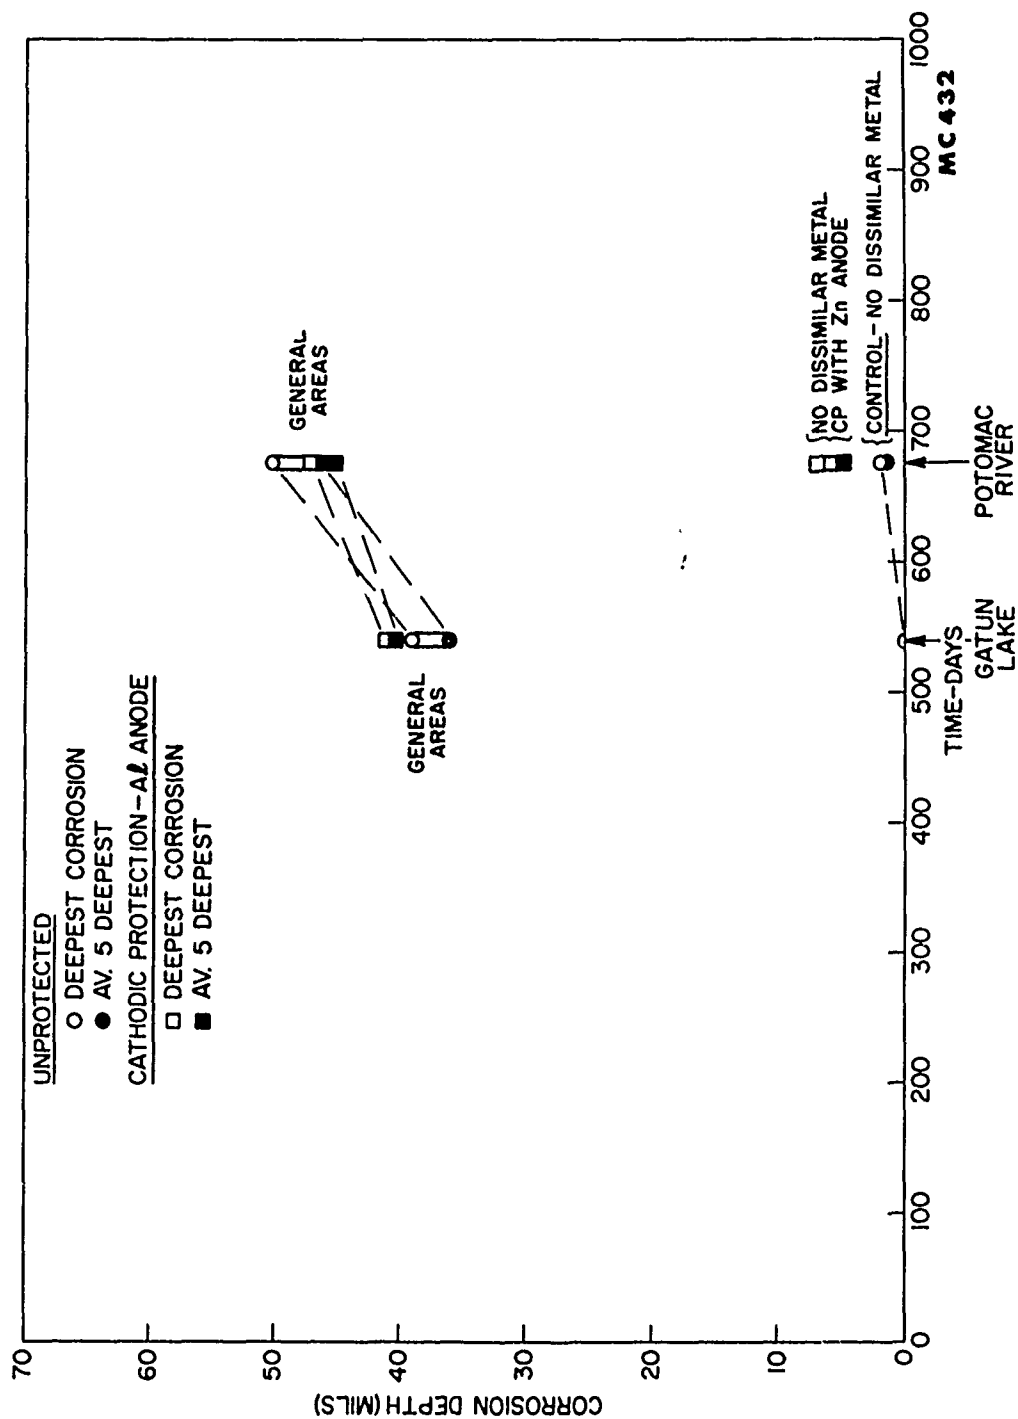
Fig. 43 - 5086-H32 aluminum coupled to yellow brass; with and without cathodic protection (CP). Data from Gatun Lake and the Potomac River exposures.

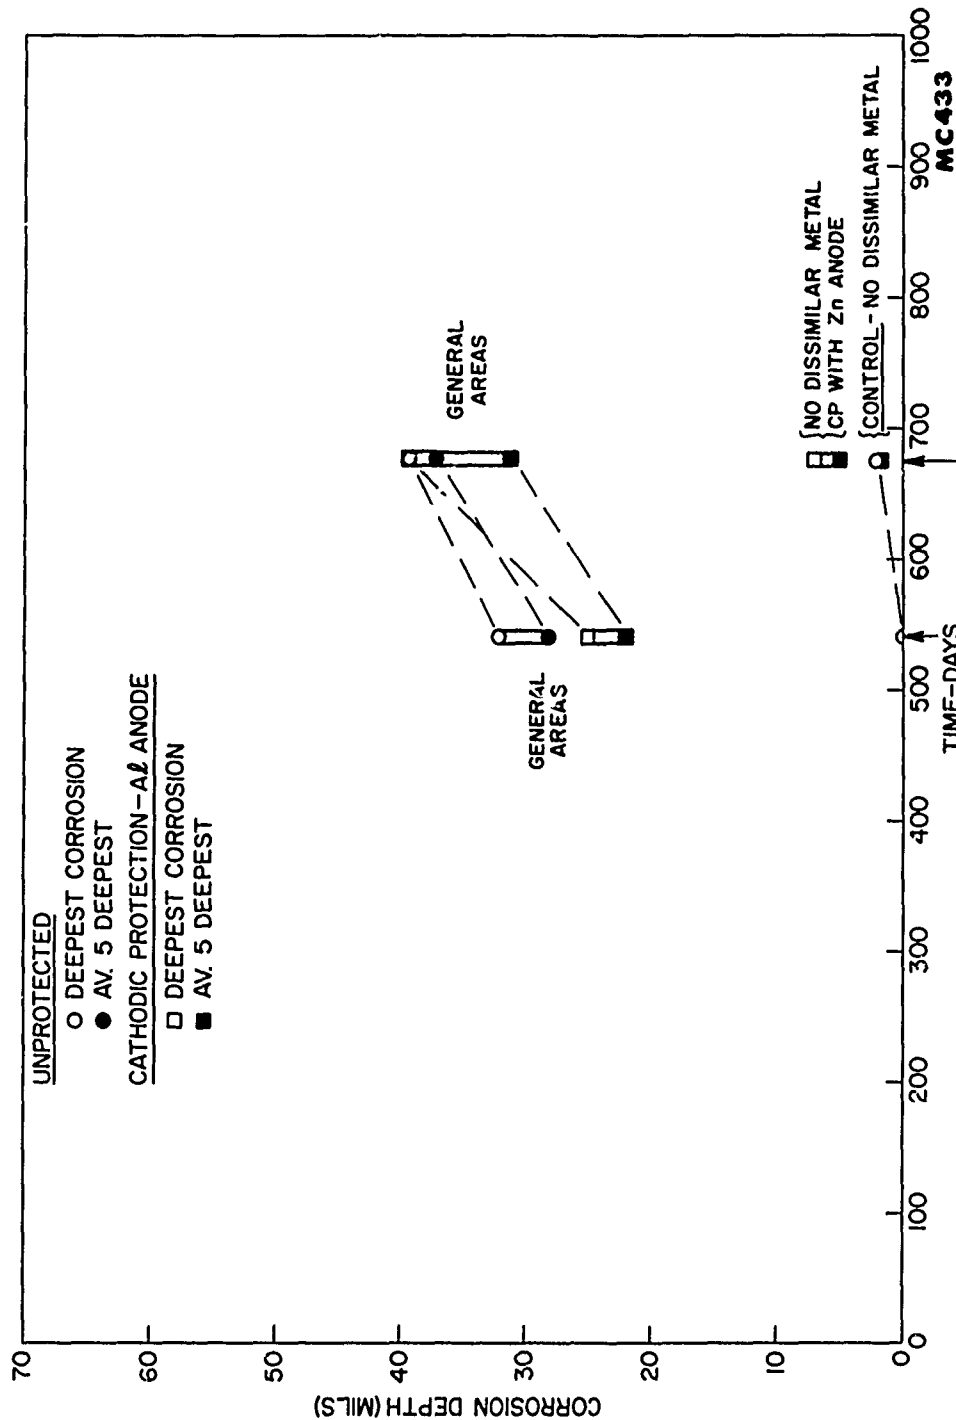
Fig. 44 - 5086-H32 aluminum coupled to 304 stainless steel; with and without cathodic protection (CP). Data from Gatun Lake and the Potomac River exposures.

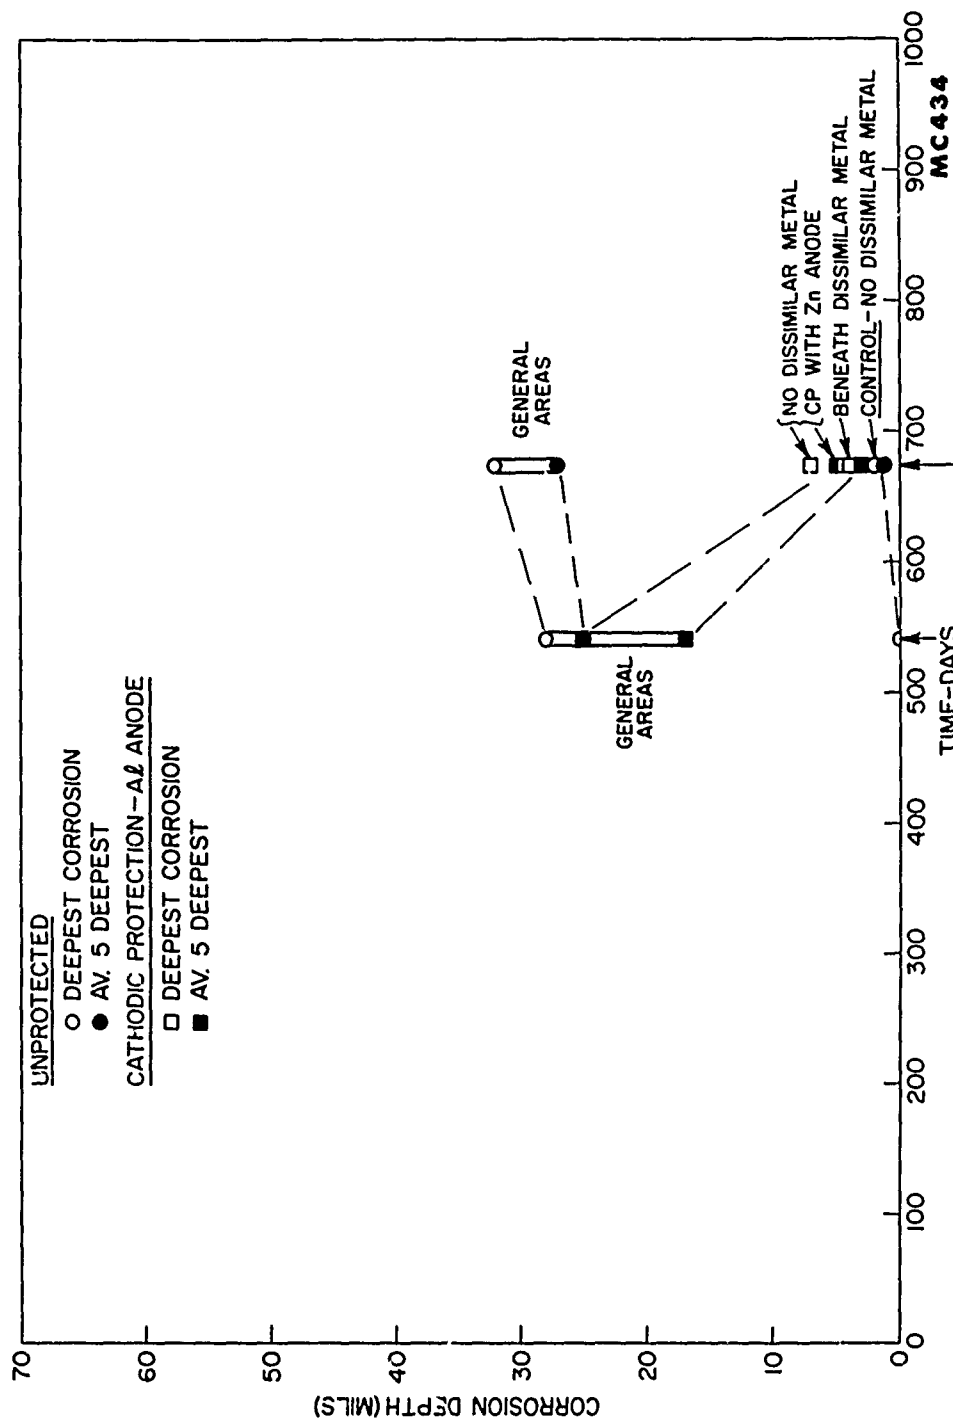
Fig. 45 - 5086-H32 aluminum coupled to mild steel; with and without cathodic protection (CP). Data from Gatun Lake and the Potomac River exposures.

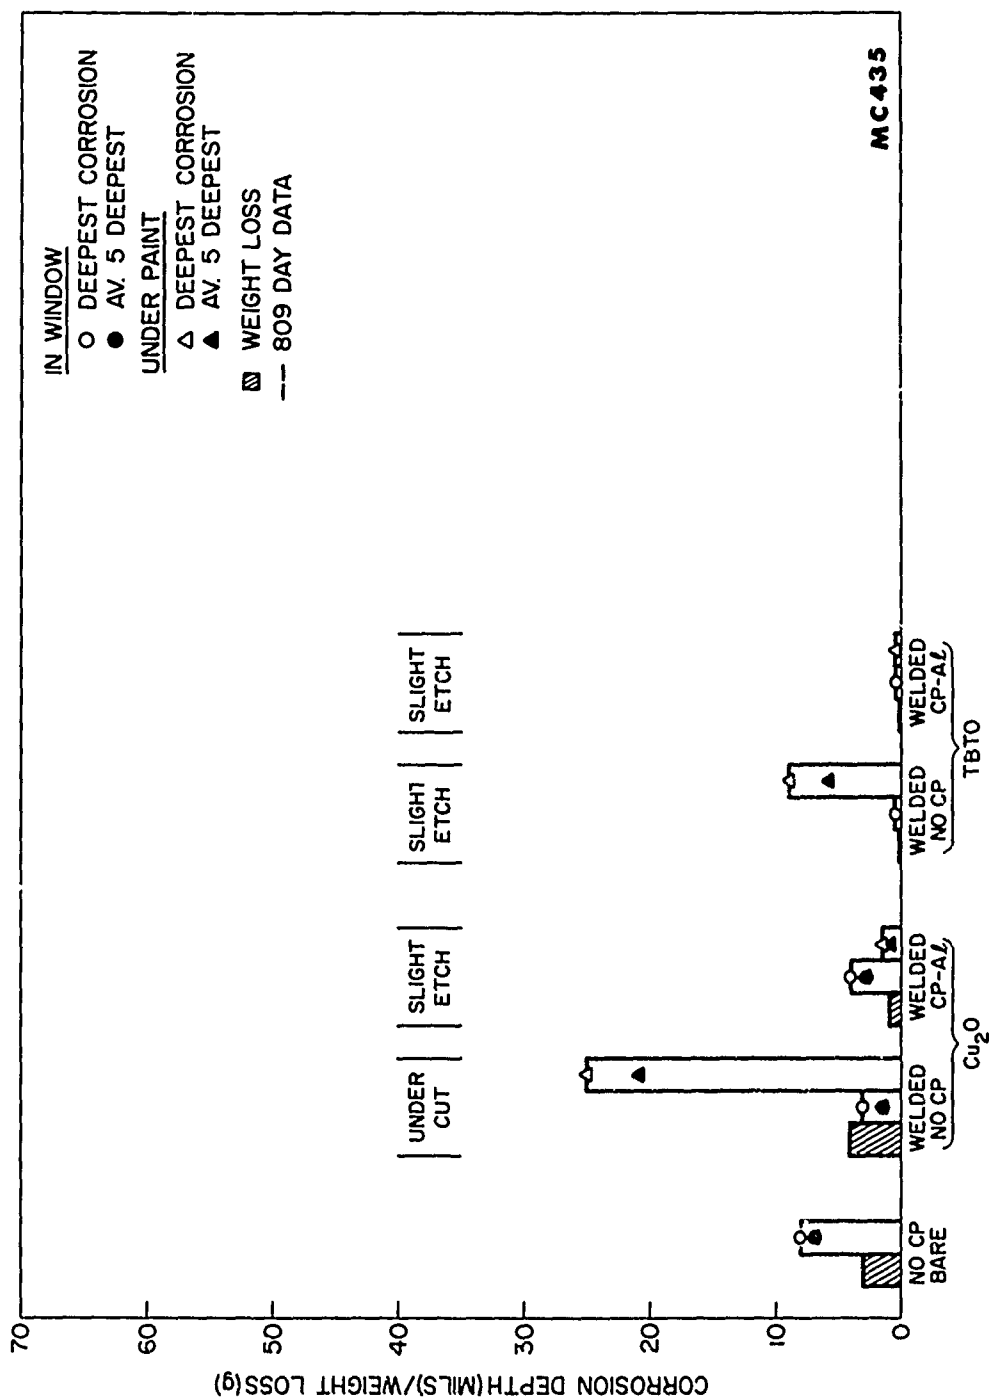
Fig. 46 - Welded 5086-H32 aluminum coated with the Standard Navy Vinyl Anticorrosive Barrier and Cu₂O or TBTO Antifouling Toxicants; with and without cathodic protection (CP), 1264 days in seawater at Key West, Florida.

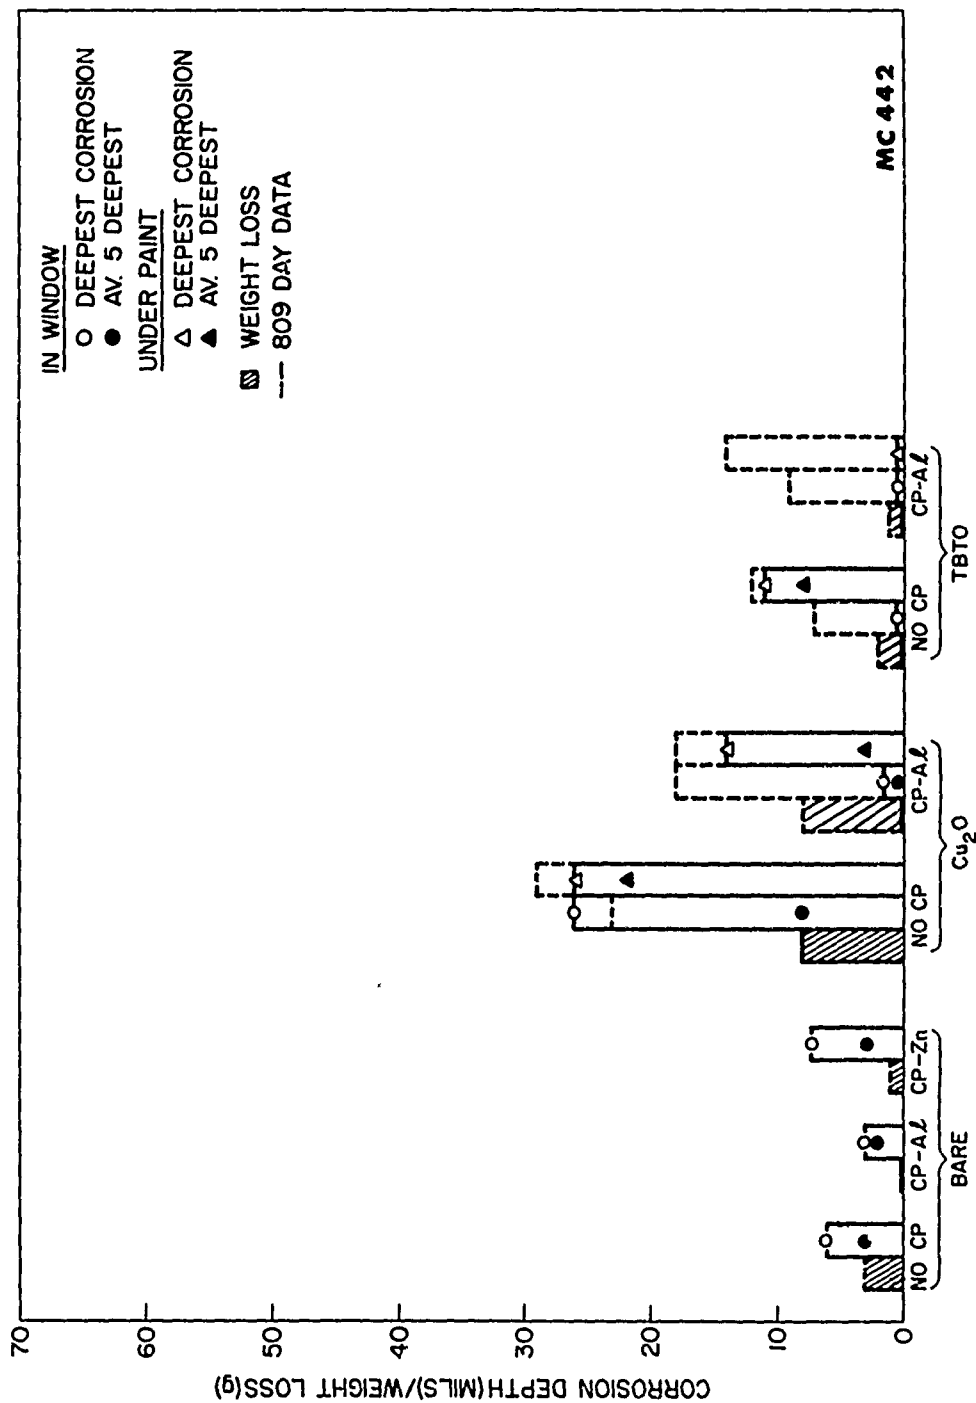
Fig. 49 - 5086-H32 aluminum coated with the Standard Navy Vinyl Anticorrosive Barrier and Cu₂O or TBTO Antifouling Toxicants; with and without cathodic protection (CP), 1264 in seawater at Key West, Florida.

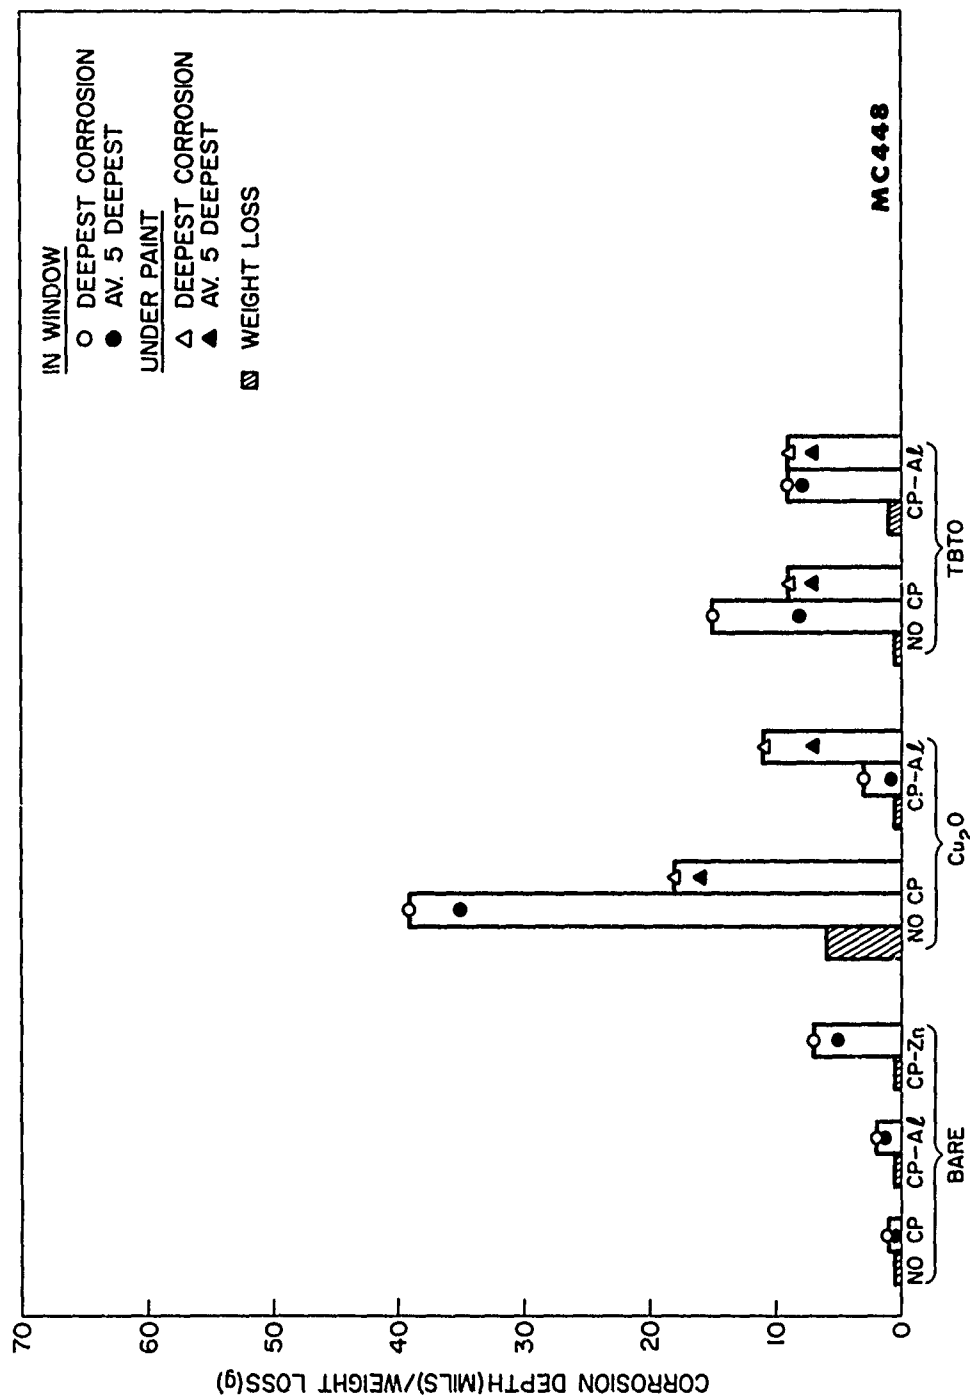
Fig. 52 - 5086-H32 aluminum coated with the Standard Navy Vinyl Anti-corrosive Barrier and Cu₂O or TBTO Antifouling Toxicants; with and without cathodic protection (CP), 675 days in the Potomac River.
